FIRE AND INDUSTRIAL SAFETY

Original article

Questions of safety of load-lifting cranes structural connections

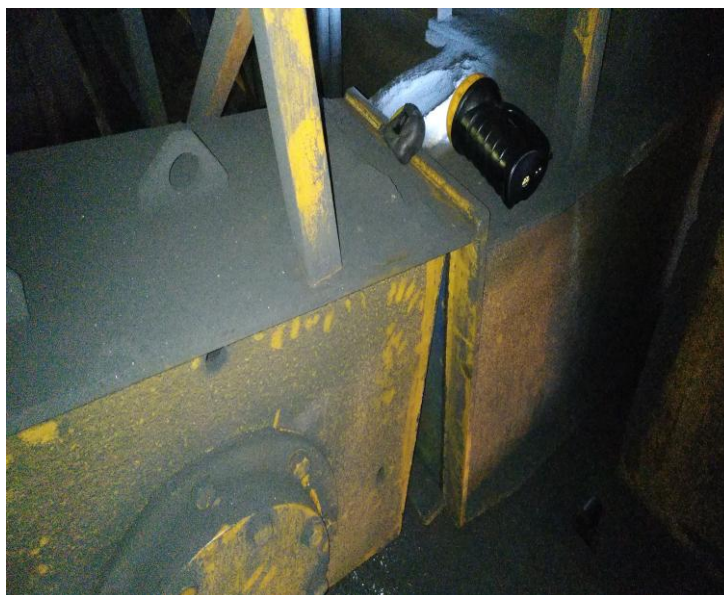
After a year of operation of the bridge crane, during the movement of the crane, when performing technological operations with an empty grab, the welded joints of the walls of the free wheel module with a vertical sheet of metal structure of the end beam were destroyed from the side of the feeding trolleys (Fig. 1). Repair and restoration was carried out. The operation was continued.

Fig. 1. Destruction of welds along the metal boundary of the fusion of the connection of the free wheel module with the vertical sheet of the end beam

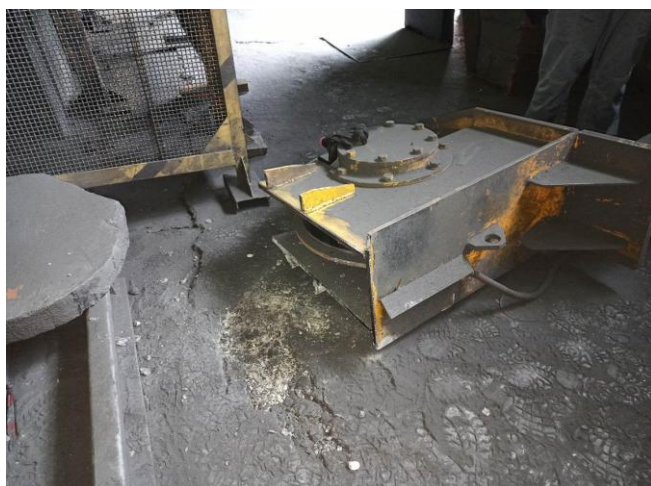
- welded joints of the module walls of the free wheel with a vertical sheet of metal structure of the end beam from the control cab side, while the wheel module fell into the aisle (Fig. 2);
- welded joints of the elements of end beams (belts and walls) with a vertical sheet of the free wheel module from the feeding trolleys side, the module wheels stay on the track (Fig. 3).

Fig. 2. Complete destruction of welded joints along the metal boundary of the fusion of the walls of the free wheel module with the vertical sheet of the end beam from the side of the crane operator's cabin

All the above-mentioned destruction of welds occurred along the metal boundary of the fusion of the elements "module elements — vertical sheet" and "end beam elements — vertical sheet". The destruction of welds on the weld metal has not been recorded.

The investigation of the crane accident showed that the destruction of the end beams occurred due to insufficient structural strength (bearing capacity) of the welded joints of elements of the free wheels modules and elements of end beams with vertical sheet, namely:

- welded joints was performed without edge preparation, seam T1 GOST 14 771-76 [6], which does not match the type of the weld specified in the passport of the crane (T6 GOST 14771-76 with edge preparation);
- the actual leg, height and cross-sectional area of the destroyed welded joints made with a T1 type seam did not provide the necessary strength of the joints;
- the actual absence of a gap (less than 0.2 mm) between the welded elements of the joints (at an acceptable value of 1.5-2 mm) prevented high-quality penetration of the welded joint;
- the geometric parameters of the destroyed welding joints of the end beam elements did not meet the requirements of the design standards according to GOST 14 771-76 and RD 36-62-00 [7].

The cause of the accident should be considered a violation of welding technologies in the manufacture of the metal structure of the end beam of the bridge crane.

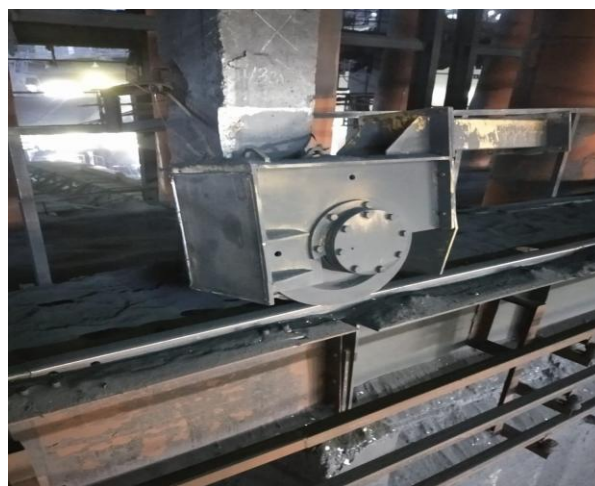
Fig. 3. Complete destruction of welded joints along the metal boundary of the fusion of the walls of the free wheel module with the vertical sheet of the end beam from the side of the trolleys

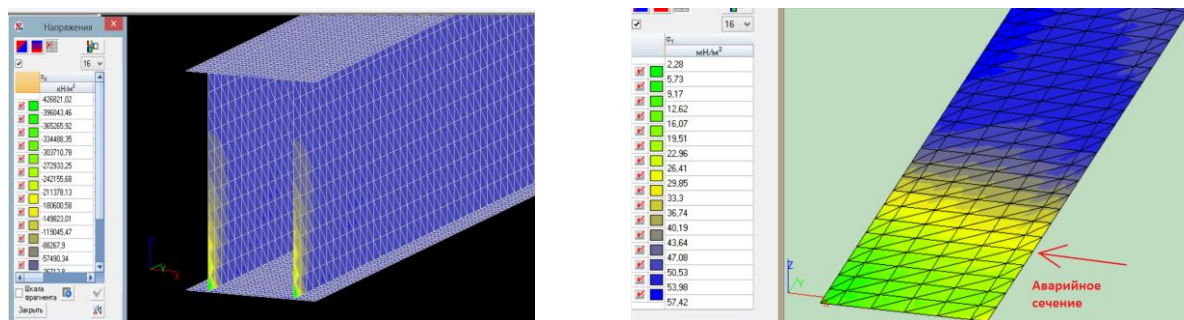
By checking the strength of the end beam of the crane using the integrated structural analysis system "STRUCTURE CAD", it was confirmed (Fig. 4) that the applied materials and metal thicknesses of the end beams correspond to its load capacity and operating loads [5].

Fig. 4 Calculation model of the crane end beam

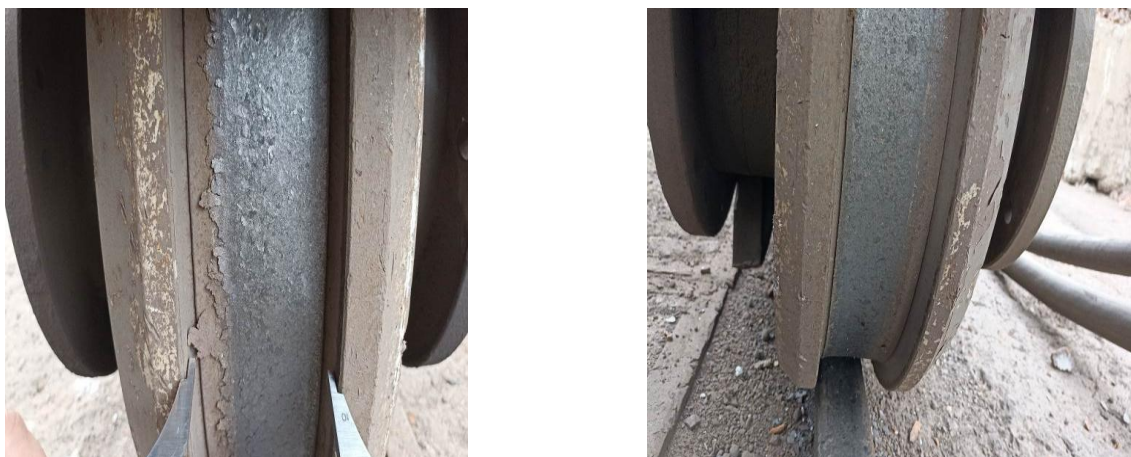
The analysis of the circumstances of the accidents showed that the working surfaces of all 16-running wheels have a characteristic wear of the rolling surface (Fig. 5) in the form of a "roll" with a height of 3-4 mm. The wheel flanges came into contact with the inside of the rail head due to the movement of the crane along curved sections of the track.

Fig. 5 Wear of the working surfaces of the running wheels

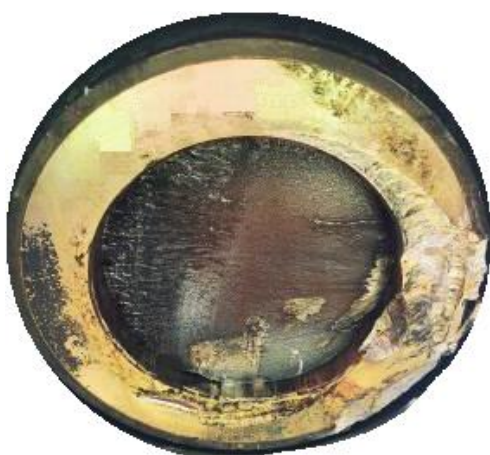
The destruction of the axles of wheeled trolleys occurred in the transition zone of the axis diameters from $\varnothing 150$ mm to $\varnothing 230$ mm. This section of the axis is characterized by an increased effective stress concentration coefficient at cyclic variable loads not lower than $K_{\sigma} = 2.5$ [11, 12]

Traces of corrosion were found on the surface of the axis fracture, which indicates the presence of an old crack with an area of about 50% of the area of the axis of the balancer. The fracture surfaces (Fig. 6, 7) have characteristic zones indicating fatigue failure of the metal resulting from the influence of alternating cyclic stresses (Fig. 8) [12, 13]:

Fig. 6. Fracture surfaces of axis No. 1

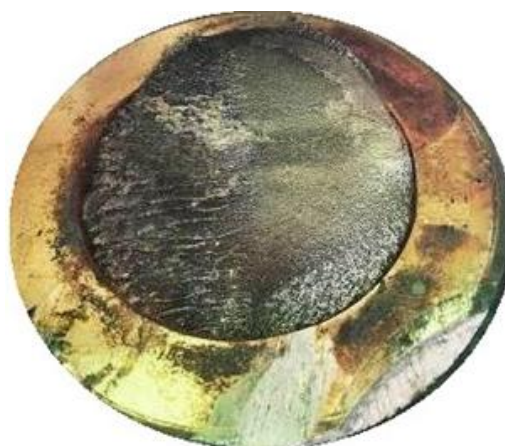
Fig. 7. Fracture surface of axis No. 2

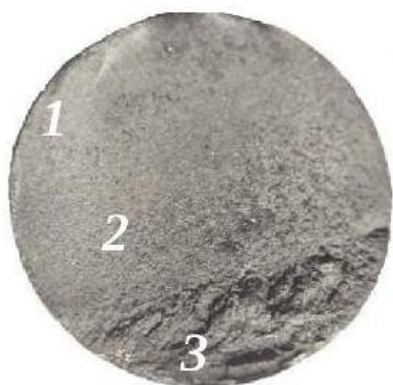
- 1 – zone of origin of the fatigue crack is located on the lateral surface of the axis in its most loaded part;
- 2 – fatigue crack development zone, has a smooth (lapped) surface;
- 3 – rupture area, has a coarse-grained fibrous structure of the surface, indicating the direction of destruction (Fig. 9).

Fig. 8. Fatigue failure with characteristic zones

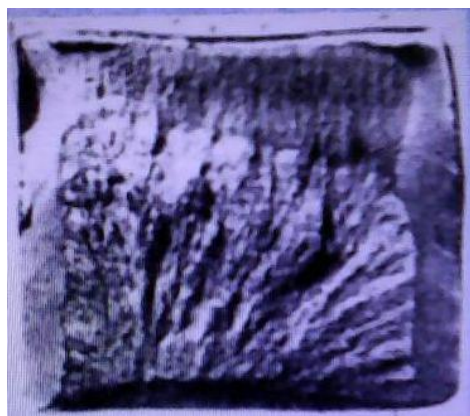
Fig. 9. Fibrous structure of the rupture area

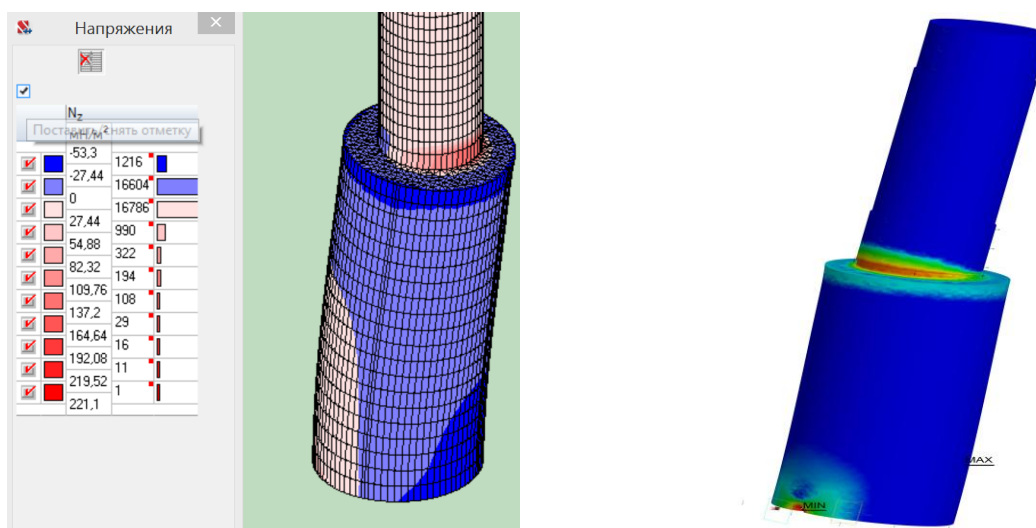
The calculations performed using the integrated structural analysis system "STRUCTURE CAD" (Fig. 10) has showed that the combination of loads during crane operation on a curved section of the track is damaging and the condition of long-term strength is not met.

Fig. 10 Deformations and stresses in the axle of a wheeled trolley

2. When operating the crane on a curved section of the rail track, the horizontal component of the force from the rotary part of the crane and the reaction from the interaction of the running wheel with the rail are transmitted to the crane gantry. The above combination of loads is damaging, which leads to the beginning and subsequent development of fatigue cracks in the dangerous section of the axes.

The cause of the accident and premature destruction of the axis of the balancing trolley is an error in the design of a complex-shaped product having a transition section with a high effective stress concentrator.
