Research Article

Destruction of Internal Anticorrosive Polymer Coatings of Oilfield Pipes during Operation

Results. Practical examples of the destruction of internal anticorrosive coatings of oilfield pipes were analyzed. For each case, characteristic signs of degradation of the anti-corrosive coating were identified. Changes in the microstructure of the coatings, as well as the formation of corrosion products, were observed depending on the type of destruction. The focus was on studying the degree of polymerization of the coating, both using the traditional method of determining the ΔT_g parameter using DSC, and based on indirect signs detected during microscopic studies.

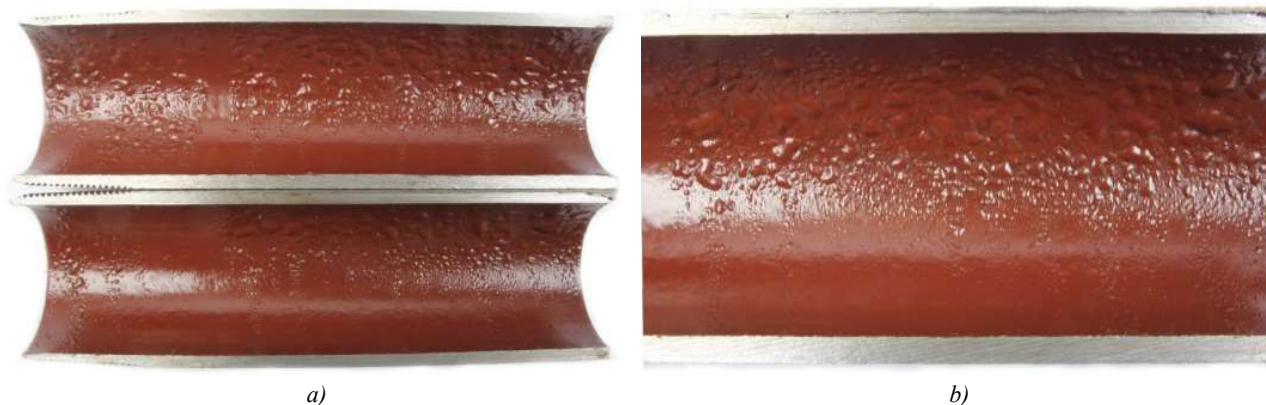
1. A fragment of tubing $\varnothing 73 \times 5.5$ mm with damage to the coating in the form of blisters along the entire length of the sample. The tubing failed after 934 days of operation (Fig. 1 *a, b*).
2. A fragment of tubing $\varnothing 73 \times 5.5$ mm with the destruction of the coating in the form of extensive areas with detachments and blisters localized mainly in the nipple part of the tubing. The time to failure was 146 days (Fig. 2 *a, b*).
3. A fragment of tubing $\varnothing 73 \times 5.5$ mm with a different color of the inner coating (Fig. 3 *a, b*).
4. A fragment of the pipeline $\varnothing 325 \times 8$ mm, with the coating destroyed, exposing the metal substrate, and a through defect in the pipe (Fig. 4 *a, b*).
5. A fragment of the pipeline $\varnothing 159 \times 8$ mm with the formation of numerous blisters of the coating and its destruction (Fig. 5).

Fig. 1. Damage to the internal anticorrosive coating:
a, b — coating blistering

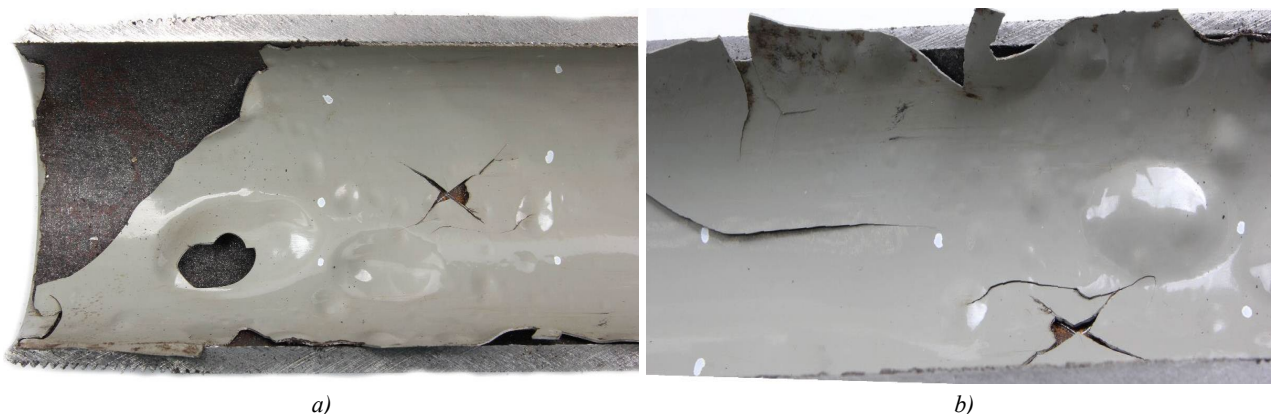
Fig. 2. Destruction of the internal anticorrosive polymer coating:
a — blistering of the coating; *b* — cracking of the coating

According to the results of the study of the tubing fragment (sample No. 2), no deviations were found in areas where the coating remained intact. However, there was a two-fold decrease in the adhesive strength of the coating in the nipple area compared to the central part of the tube. The thermokinetic characteristics were determined by differential scanning spectroscopy (DSC) with determination of the glass transition temperature (T_g) of the coating along the entire length of the tubing. The results of the analysis did not reveal a significant variation in T_g values of the studied areas, which may indicate uniform heating during the polymerization of the coating.

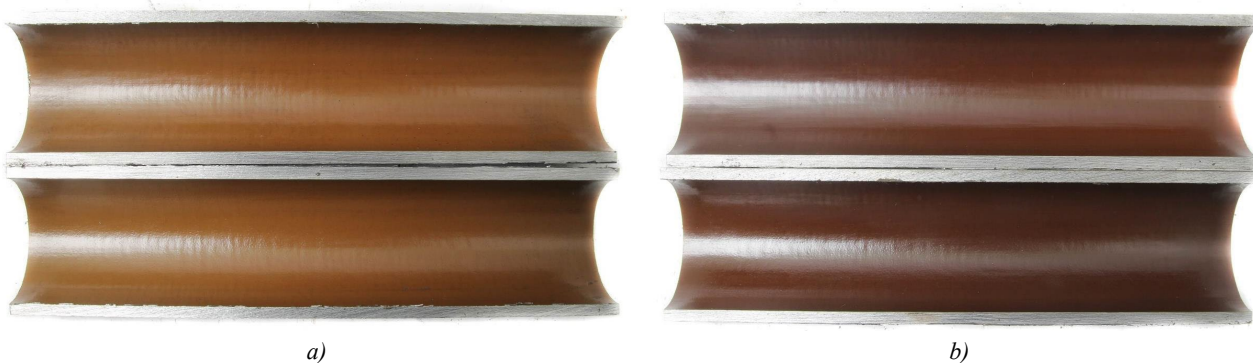
Fig. 3. Different shades of the internal anticorrosive coating of the tubing:
a — light brown shade of the coating; *b* — dark brown shade of the coating

Upon visual inspection of the inner surface of the tubing (sample No. 3), it was found that the anticorrosive coating had a different shade. No visible coating defects, such as blisters, separations, or cracks, were found. However, when determining the dielectric continuity in the area with the dark brown coating (Fig. 3b), numerous breakdowns were detected, indicating a possible violation of the polymer's integrity due to the presence of microcracks. Taking into account the results of the conducted research, it could be concluded that the heterogeneity in the shade of the anticorrosive coating was likely due to under-polymerization during the drying process. Polymerization is achieved through exposure to high temperatures in specialized ovens, where chemical reactions between polymer chains take place. To ensure uniform heating of the coating during the curing process, it is essential to maintain a constant temperature. Any violation of the temperature-time polymerization regime directly affects the rate of chemical reactions, and as a result, can lead to the destruction of the polymer.

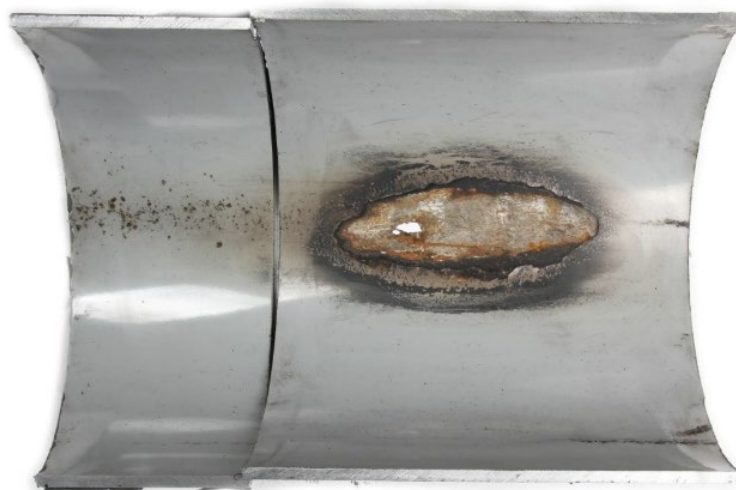
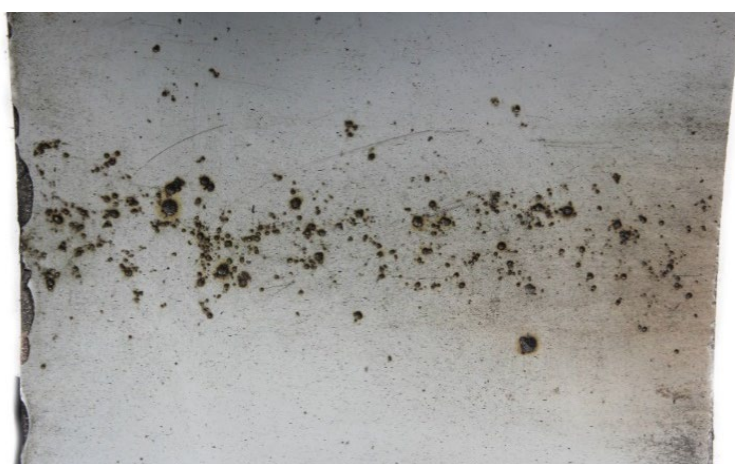
Fig. 4. Damage to the internal anticorrosive coating of the pipeline $\text{Ø}325 \times 8$ mm:
a — general view of the destruction of the coating; *b* — burns of the coating

As an example, we can consider damage to the powder-based inner coating caused by repair work on Ø325x8 mm pipeline (sample No. 4). The damage to the coating was severe, leading to the exposure of the metal substrate and the formation of a through defect in the pipe. External signs, such as the presence of blisters and a change in the color of the coating to black, indicated an additional temperature effect on the pipe at temperatures above 250°C (Fig. 4 a). In this case, welding work carried out during repair of the pipeline resulted in the formation of burns and burnouts in the coating (Fig. 4 b), due to violation of integrity and continuity of the coating. As a result, the transported medium could easily penetrate through the polymer layer to the metal of the pipe, activating corrosion processes. The intensity of corrosion in a pipeline could be increased by the presence of corrosive substances in the transported fluid, such as dissolved gases like CO₂ and H₂S. It could also be influenced by factors such as the velocity of the fluid flow, temperature, and pressure within the pipeline.

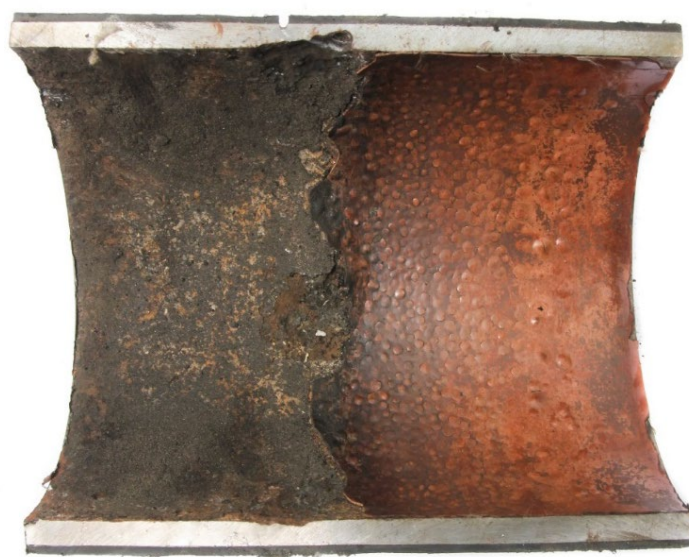
Fig. 5. Destruction of the internal anticorrosive coating of the pipeline $\text{Ø}159 \times 8$ mm

There are often cases where the destruction of an anticorrosive coating can have a complex mechanism and be accompanied by a combination of several factors. Microstructural studies of the Ø325x8 pipeline showed that the destruction of the coating occurred through the mechanism of decompressive peeling, which happened under the influence of a sudden pressure drop [1]. The penetration of gases through the coating reduced the barrier properties of the anticorrosive coating, leading to the development of corrosion on the pipe metal and the formation of corrosion products (Fig. 8). In addition, given the scale and nature of the destruction of the anticorrosive coating layer, it could be established that the main cause of damage to the pipeline was a local thermal effect applied from the inner surface of the pipe. In this case, high-temperature heating led to overheating of the internal anticorrosive coating and its destruction.

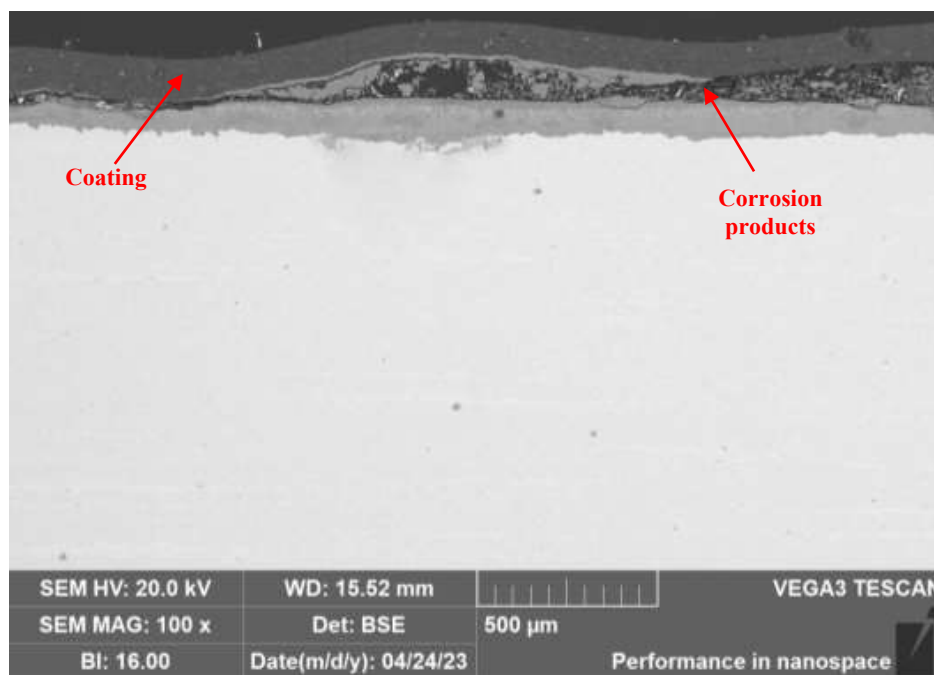
Results. Microstructural studies of the anticorrosive coating of the tubing (sample No. 1) revealed complete detachment of the coating from the metal with the development of corrosion processes. This indicated that the formation of a corrosion layer with a thickness of approximately 122 microns was due to the prolonged penetration of aggressive components of the transported medium into the metal substrate (Fig. 6). Studies have not revealed any significant deviations or imperfections in the coating, such as local areas with reduced thickness or the presence of shot particles underneath the coating layer. These findings were consistent with the common occurrence of such phenomena during the shot blasting process of the metal surface prior to applying an anti-corrosion system. Based on these results, it could be concluded that the destruction of the coating through this mechanism was not the cause of the observed corrosion processes in this particular case [16]. These signs indicate damage to the anticorrosive coating caused by the operational impact due to the downhole work carried out to remove impurities and plugs in the tubing trunk using chemical reagents — hydrochloric acid treatments. It was also impossible to exclude an overpressure in the system, as a result of which gas penetrated into the coating volume as a result of diffusion permeability and its sharp expansion, which contributed to the destruction of the coating by decompression mechanism with the formation of blisters [1].

Fig. 6. Microstructural studies of the anticorrosive coating in the area of its damage

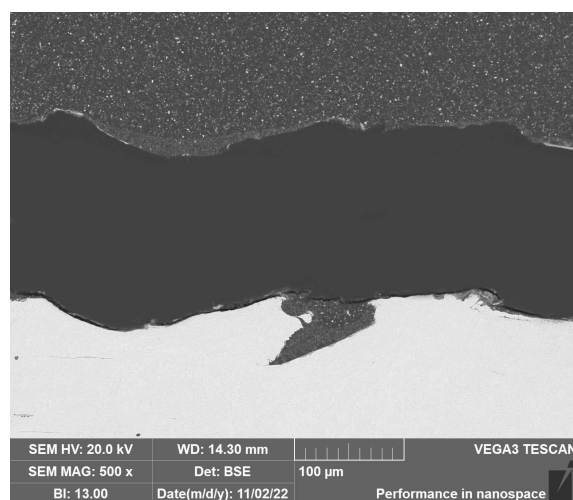
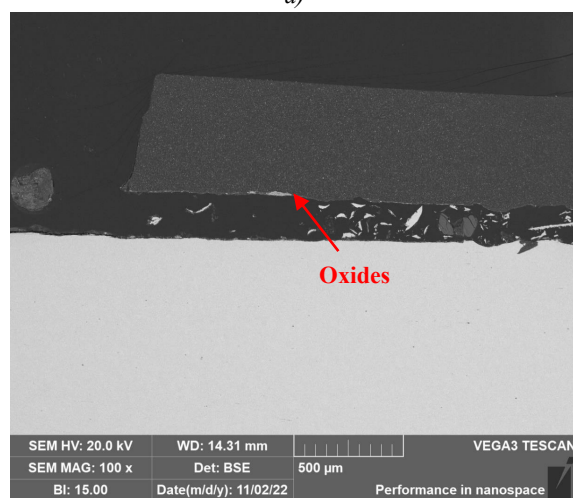
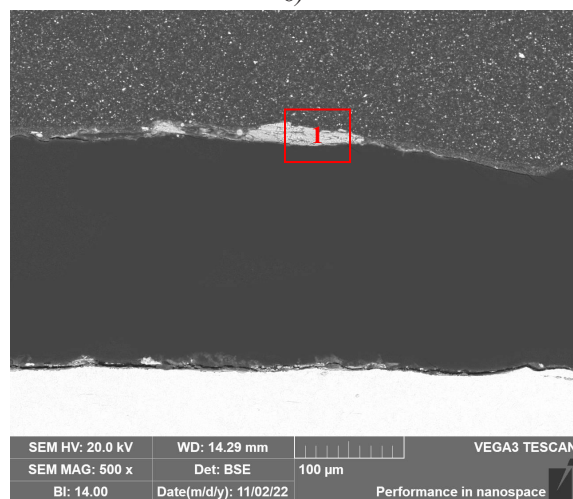
Microstructural analysis of the anticorrosive system has established that the peeling of the coating occurred along the primer layer and was characterized by a cohesive nature of destruction. In addition, oxide particles were present on the surface of the metal of the pipe and the detached part of the coating (Fig. 7, Table 1). In this case, inclusions of iron oxides on the inner surface of the pipe may have formed due to inadequate cleaning and surface preparation prior to coating.

The considered example was a frequent case of destruction of the polymer coating associated with a violation of the technological processes of preparing the inner surface of the pipe before painting.

Fig. 7. Microstructural studies of the coating in the area of its destruction:
a — peeling of the coating from the metal;
b — presence of a layer of oxides; c — chemical composition of oxides

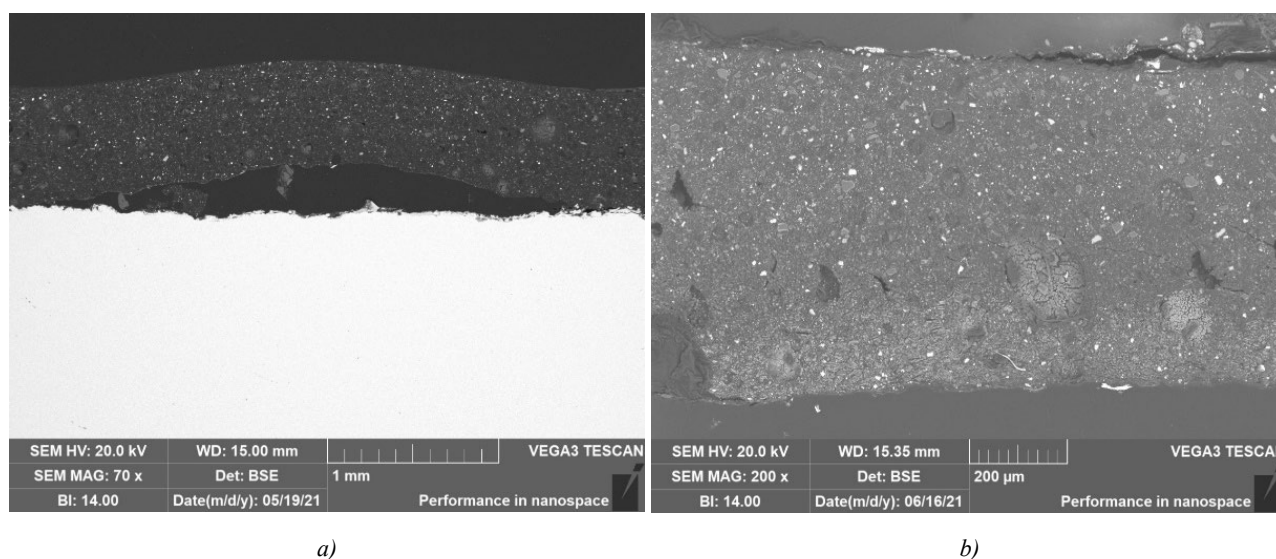
Fig. 8 Microstructural studies of anticorrosive coating in the field of destruction: *a* — peeling of the coating; *b* — destruction of the polymer coating
